INVESTIGATION OF GREASE-LUBRICATED EXPENDABLE SPLINE CONNECTIONS

FINAL TECHNICAL REPORT
Contract N68335-75-C-1117

Naval Weapons Engineering Support Activity
Systems Engineering Department
Washington Navy Yard
Washington, D.C. 20374

October 20, 1976

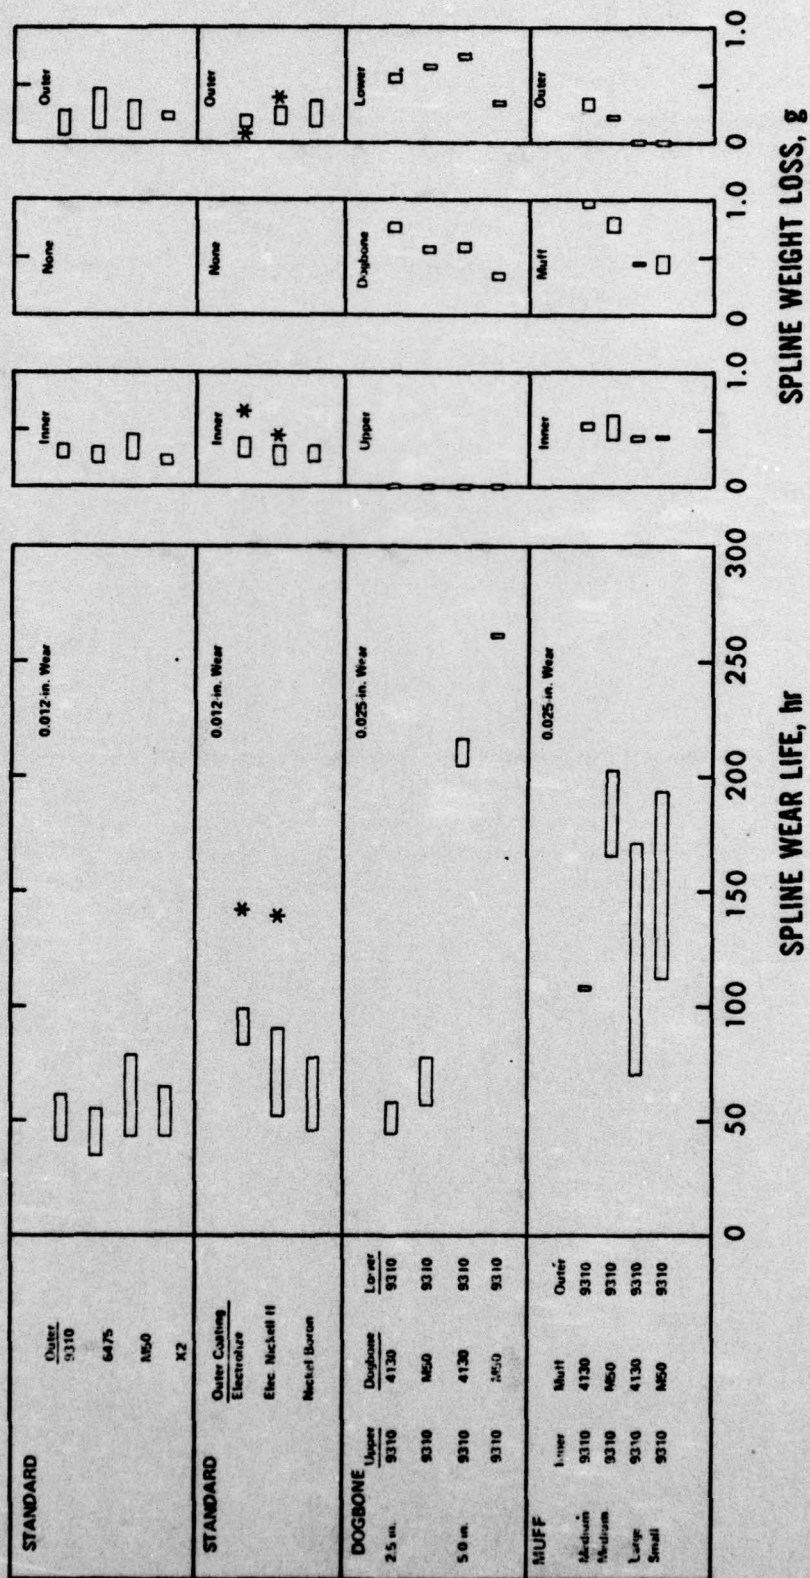
FIGURE 17. PERFORMANCE SUMMARY FOR STANDARD, DOGBONE, AND MUFF SPLINE CONNECTIONS

A summary of the results of the spline wear tests performed is presented in Figure 17.

Dissimilar Materials. Two tests were performed (see asterisks in Fig. 17) with an inner spline of AISI 4130 steel and an outer spline of AISI 9310 steel, with Electrolize and electroless nickel II coatings. The splines were of equal hardness. A large fit was used. A near three-fold improvement in spline life was obtained. However, in both tests, the
